PRELIMINARY REPORT

Pendower Beach Hotel (Pink Hotel)

Pendower Beach, Veryan

Carried out on 9 August 2016

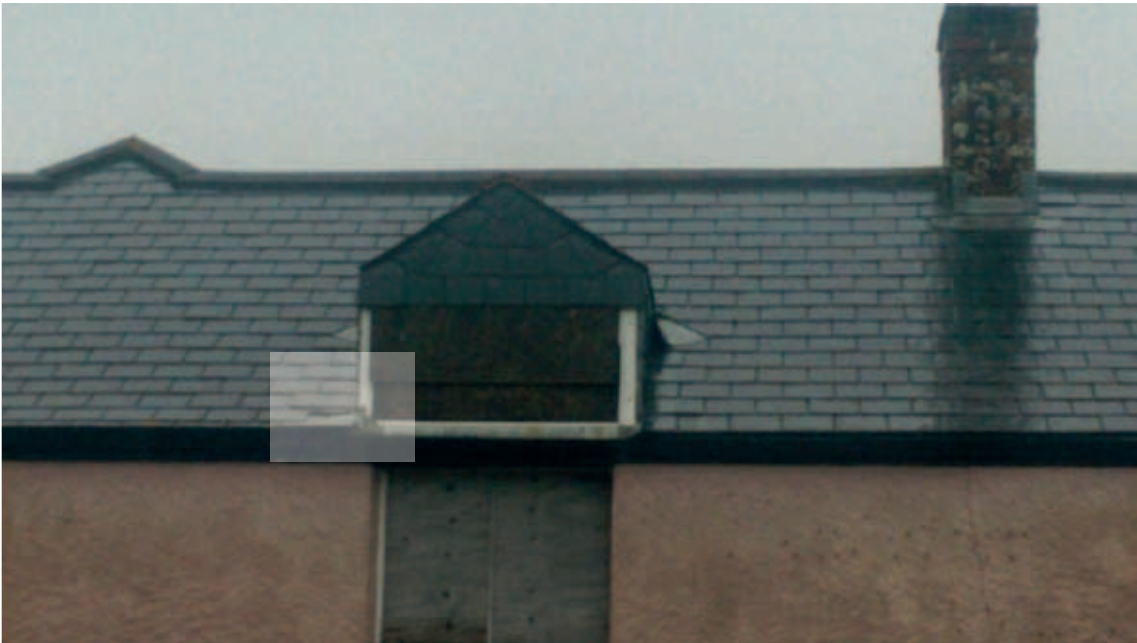
Almost the entire span of roof tiles has been replaced in recent years. The slate looks to be in sound overall condition with a few noted cracked or missing tiles (please see appendix F Photo 1 as an example of this). Water will have penetrated the roof at these points and therefore it is important to inspect the roof timbers for wood rot and / or fungus growth. Some of the timbers may require replacement. Structural defects would only be evident upon a close internal inspection. Where the old tiles remain, these have light moss growth and would require cleaning and / or replacing within the next few years.

Photo 1 - new slate tiled roof, missing tile beside lower left dormer

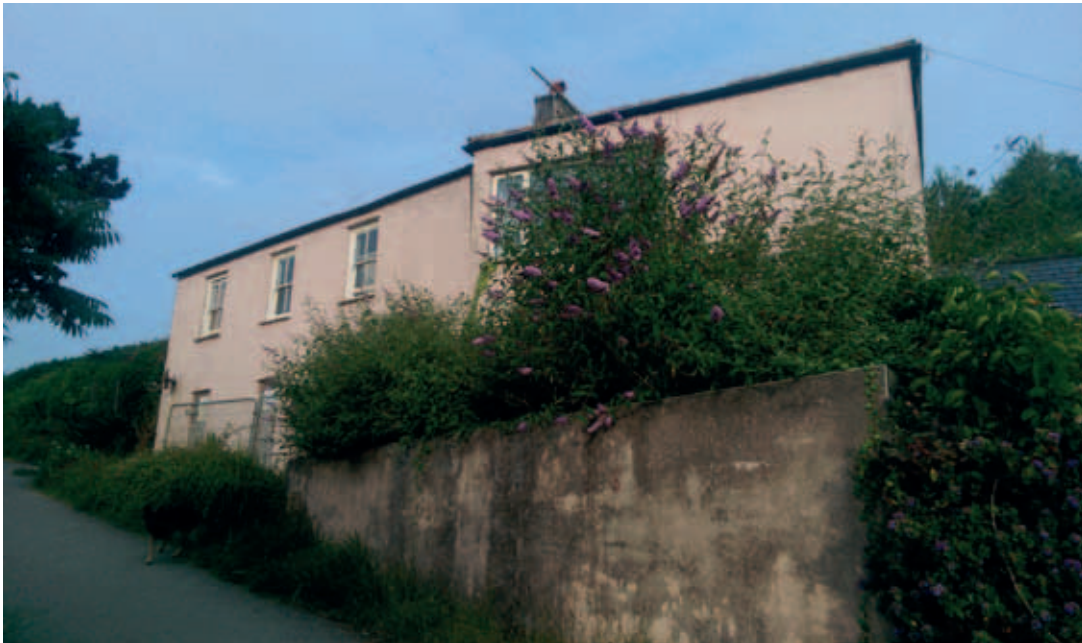
Vegetation has been left to grow close to the property and there are signs of building penetration on the south side (please see Appendix F Photo 2 for evidence of this). Plant growth may cause moisture retention or prevent the building from drying naturally and therefore it is likely there would be damp issues. Insects and fungi thrive in moist conditions so these areas would need to be inspected and addressed prior to any work commencing.

Photo 2 - overgrown vegetation (Block A)

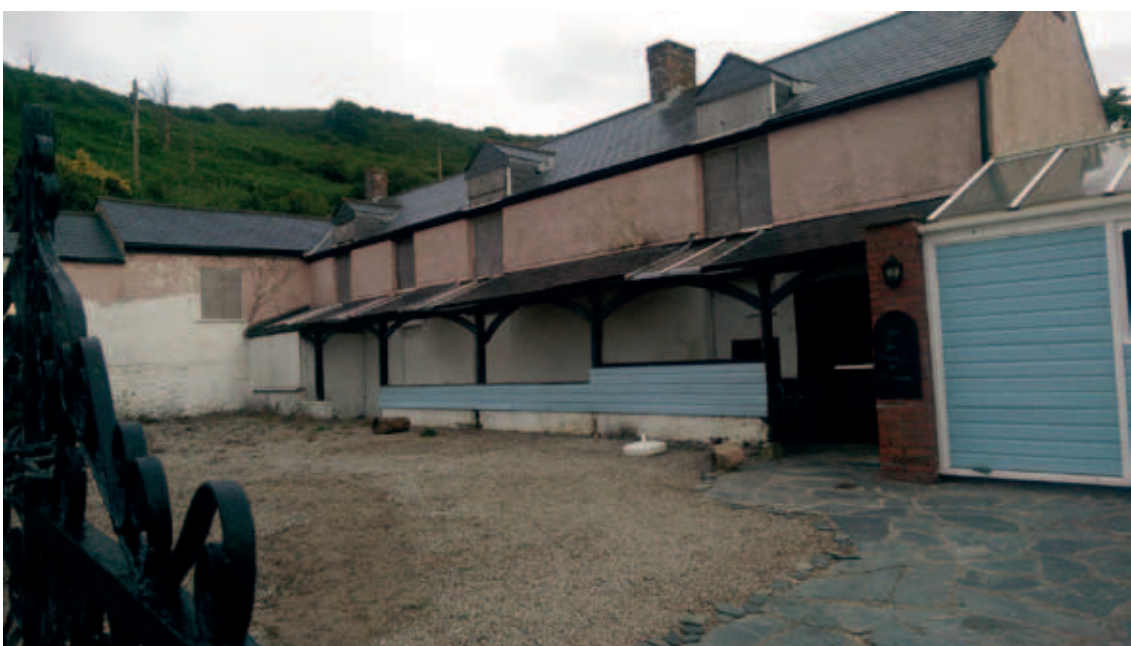
Photo 3 - reception and bistro / restaurant (Block B & C)

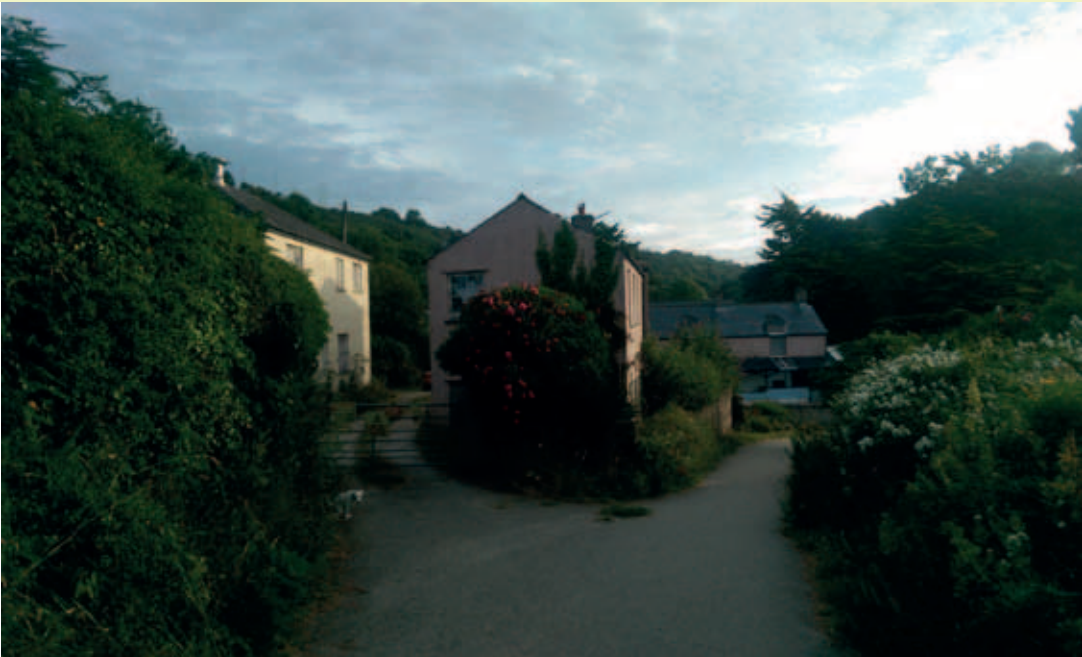
Photo 4 - driveway / access and blocks F, A and C in the distance

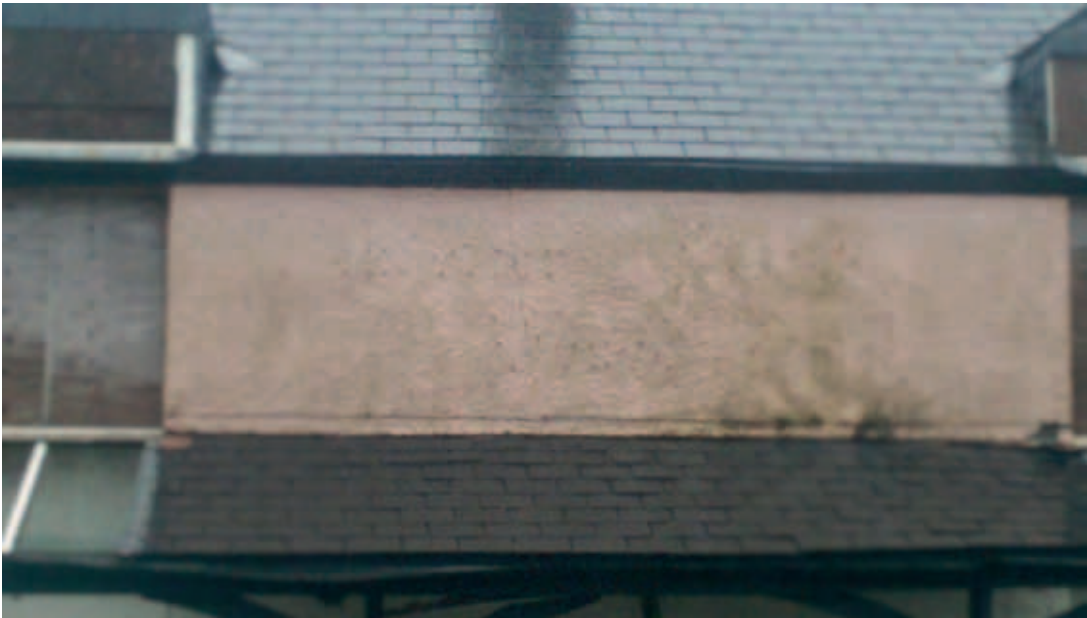
There was visible cracking on two separate outer walls which appear to be old. They would need to be monitored as they could be a result of subsidence caused by weakened foundations. They may simply be a result of natural settlement. Please see appendix G Photo 1 for evidence.

Photo 1 - evidence of a vertical crack (Block C)

It is recommended that the cracking noted on the exterior parts of the building be seen by a Structural Engineer. A local company can be recommend to carry out this survey.

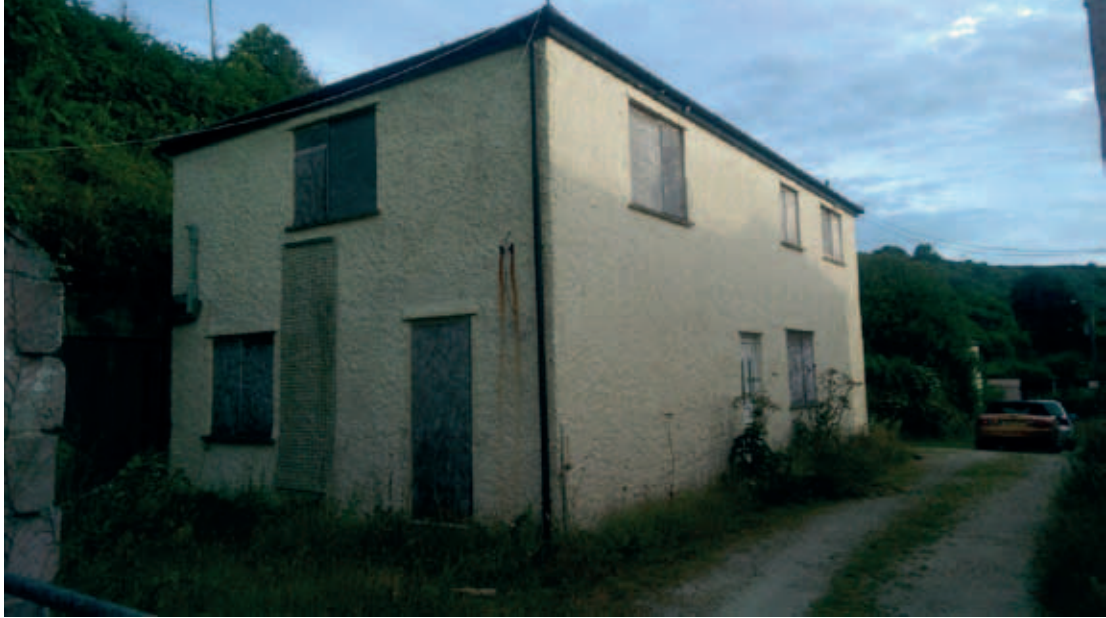
The majority of window openings have been boarded up due to vandalism and the windows

which remain are shown to be of casement type, single glazing within a wooden frames which have been subject to rot and weathering. All window and door openings would require replacement. Please see appendix G Photo 2.

Photo 2 - boarded up windows and doors (Block F)

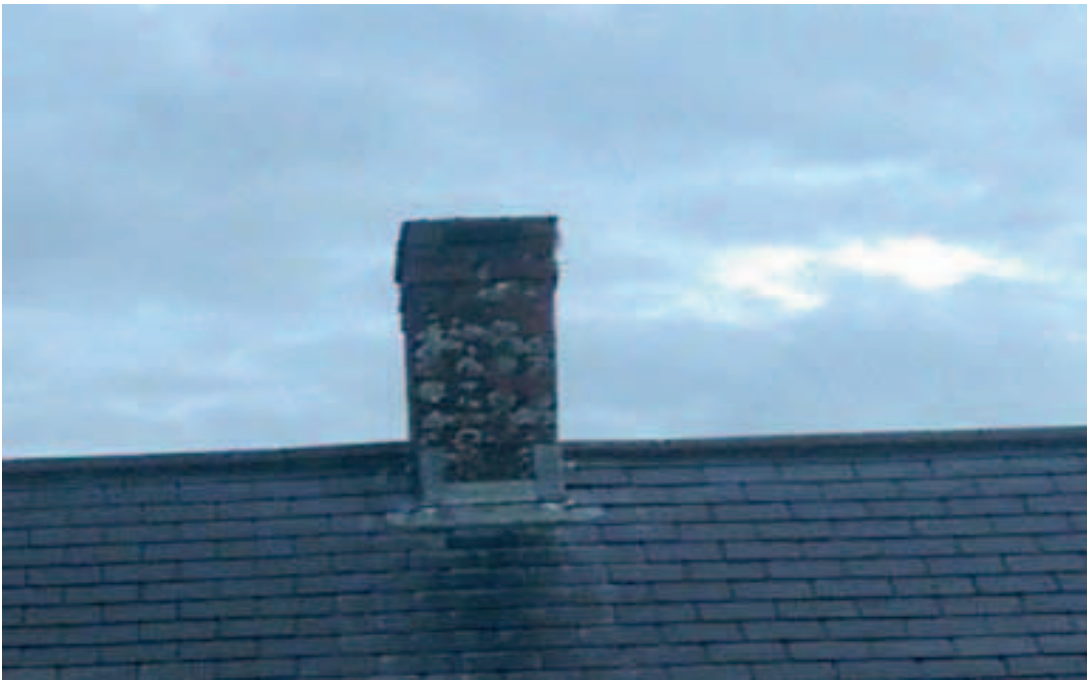
There are five chimney stacks located on the ridge line of the roof structures. They are of brick and mortar construction and look to be in reasonable condition with no noticeable cracking. The brickwork on the chimney pots should be cleaned. The mortar can crack over time and allow water penetration so should be monitored. Where the stack abuts the roof line there are lead cover flashings, which from the ground level appear to be in reasonable condition. Please see appendix G Photo 3.

Photo 3 - brick chimney stack and lead flashing

There should be an internal inspection to ensure the stacks are adequately supported as these are load bearing and therefore support the structural integrity of the building. If they are to remain open and used, they must be checked by a qualified HETAS engineer.

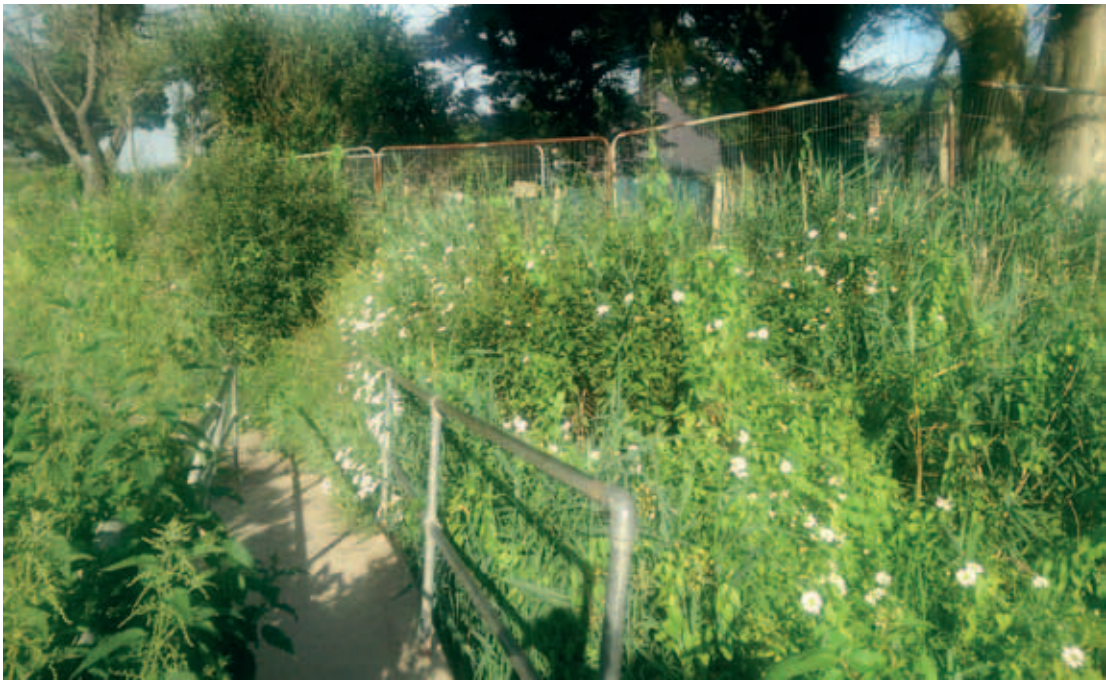
Access to the site is restricted to pedestrian access only. To the west is The Rocky Lane entrance side which is affected by coastal erosion, currently managed by The Environment Agency. According to their prediction, erosion over the next 50 years is approximately 1-2 meters. The drive has been closed off to all vehicles, although the current caretaker keeps a vehicle on site. A small river runs adjacent to the property on the East side and there is a narrow public footbridge providing access to both the National Trust car park via a sandy footpath, and to the beach (see location map in Appendix A and Appendices F & G Photo's 4).

Photo 4 - footbridge over the river toward the property
